# Maryland Historical Trust HISTORIC PROPERTIES State Historic Sites Inventory Form

Survey No. B-4330 Magi No. DOE \_yes \_no

e (indicate pre	eferred name)		
	106 N. Howard S	treet		minued entires.
historic	Elegance			
and/or common	AND IN TERE	west ominibud it	1840 commercia	southweight

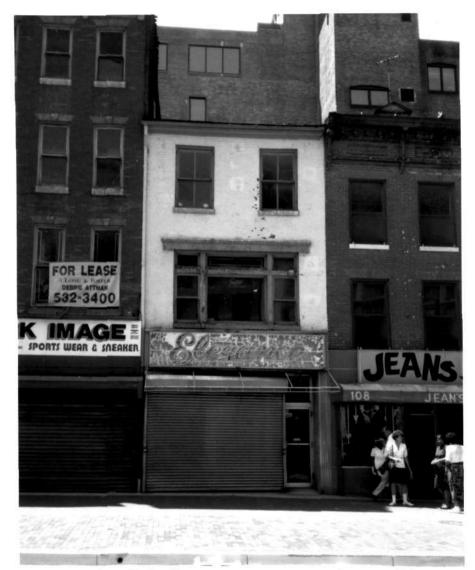
B-4330 106 N. Howard St. Baltimore MD Brane Shaw 8/91 Manyland SHPO Facade, east elevation 1/2

This circa 1840 commercial building faces east on N. Howard Street and abuts two partywall structures. The two-bay, threestory, brick building has 20th-century alterations on the first story and late 19th-century alterations on the second. It may have originally been a domestic building converted to commercial usage. The brick is painted cream and the trim is painted mustard yellow. The street frontage is 16' and the depth is 64'6".

The first story has been completely altered. Most of the vacant building is currently obscured by roll-down theft guards. A glass door with transom is positioned on the north edge of the facade. A plastic, boxed sign board runs between the first and second stories. The metal ribs for an awning hang without fabric.

The second story has a tripartite "Chicago" window centered on the facade. Set in wood surrounds, the window consists of a large central pane of glass flanked by narrow 1/1 sash on either side. Each window has a transom. The center transom has silver tape outlining a geometric border around the perimeter of the glass. A molded lintel runs across the tops of the windows. It has a fillet, quarter round, bead and back band profile.

The third story has two 2/2 sash windows with stone sills and brick splayed jack arches.

The cornice is of three corbelled brick courses.

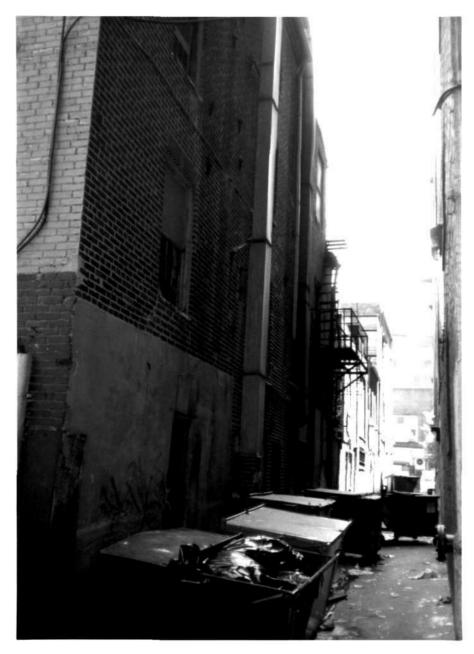
B-4330 106 N. Howard St. (near) Baltimore MD Diane Shaw 8/91 Mary and 5HPD Rear alley (west elevation) 2/2

The back (west) wall is three bays wide and two stories high. The first story has a window in the first bay, a door in the second, and a now-blocked door in the third. The second story has three now-blocked windows. The windows have wood sills and header brick lintels. The cornice is a one corbelled brick course.
